**KOOTENAI DEVELOPMENT IMPOUNDMENT DAM  
DECEMBER 26<sup>TH</sup>, 2007 ROUTINE INSPECTION REPORT**

**BILLMAYER & HAFFERMAN ENGINEERING INC.**

**February 23, 2008**

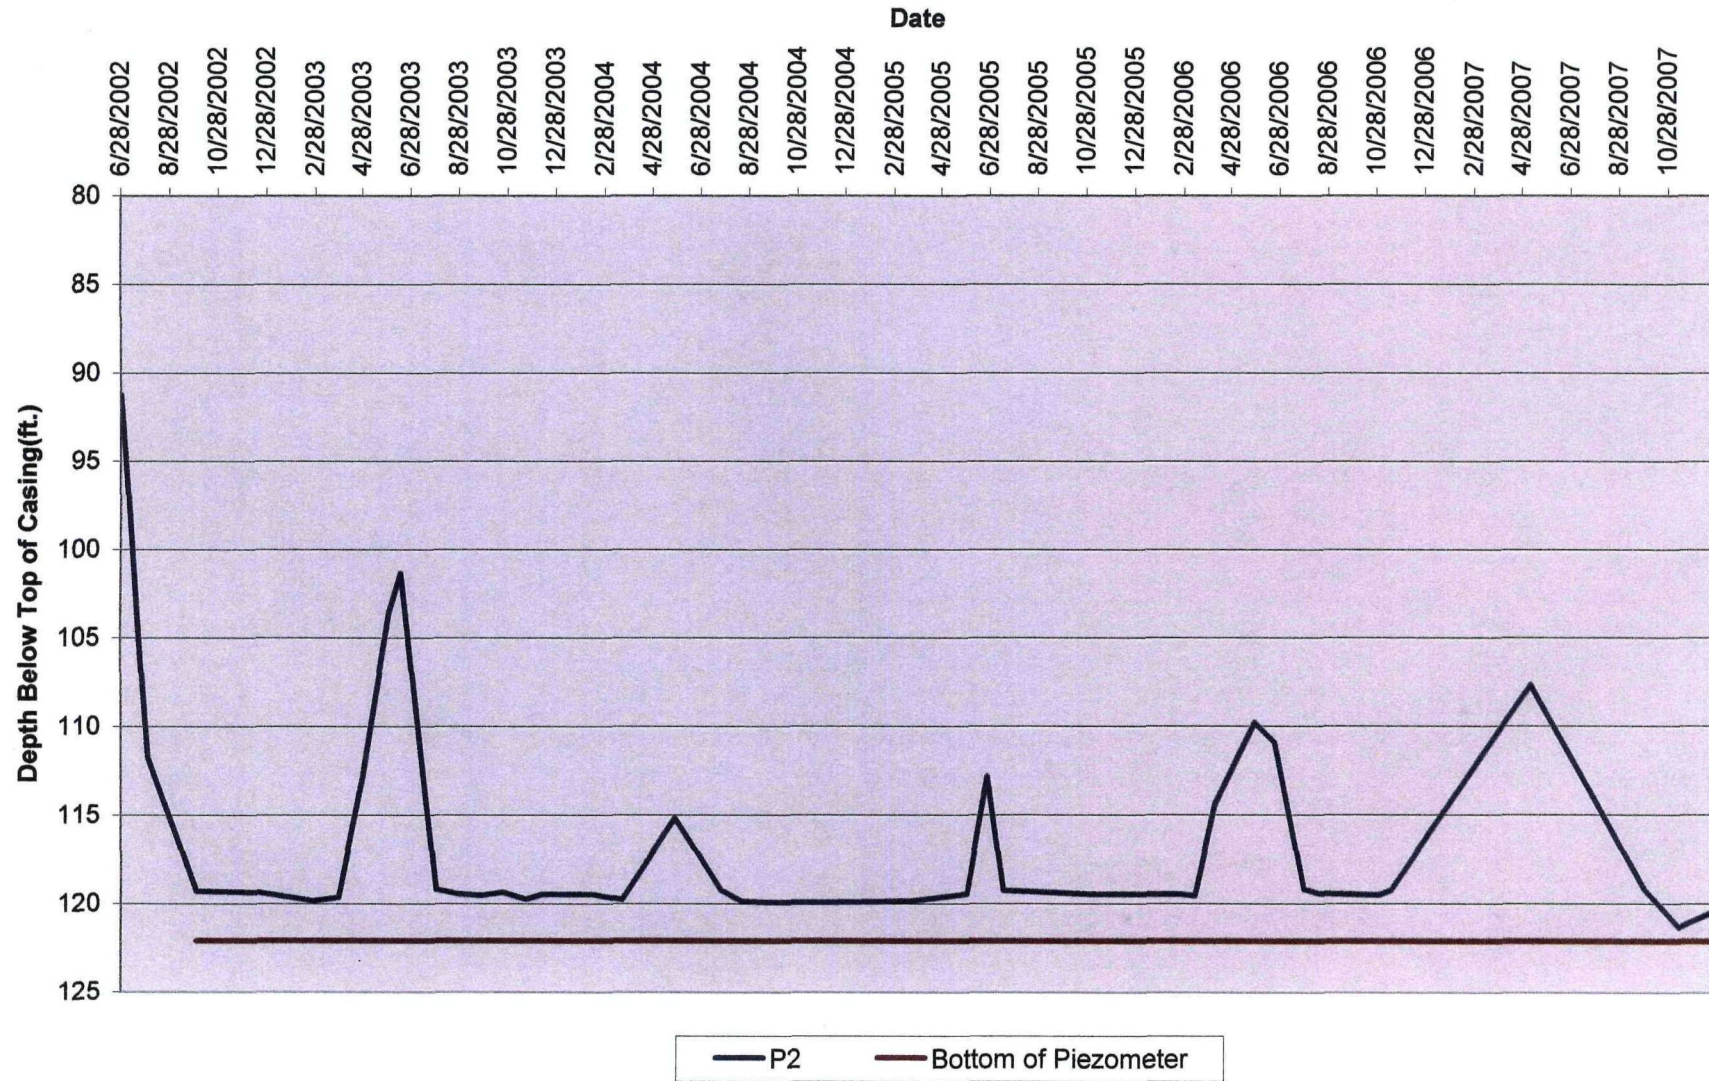
## Depth to Water in P2

P-O	NA	NA			
P	DRY	102.35		DRY	
P1		103.4		DRY	
P2	120.34	122.5	WET		2.16
P3	DRY	60.65		DRY	
P4	106.2	106.2	WET		0
P5	104.01	104.3	WET		0.29
PM1	51.52	54.81	WET		3.29
PM2		103.98		DRY	
PM3		51.78		DRY	
PM4		41.12		DRY	
PM5		49.57		DRY	
PM6		65.69		DRY	
A8	8.52	28.26	WET		19.74

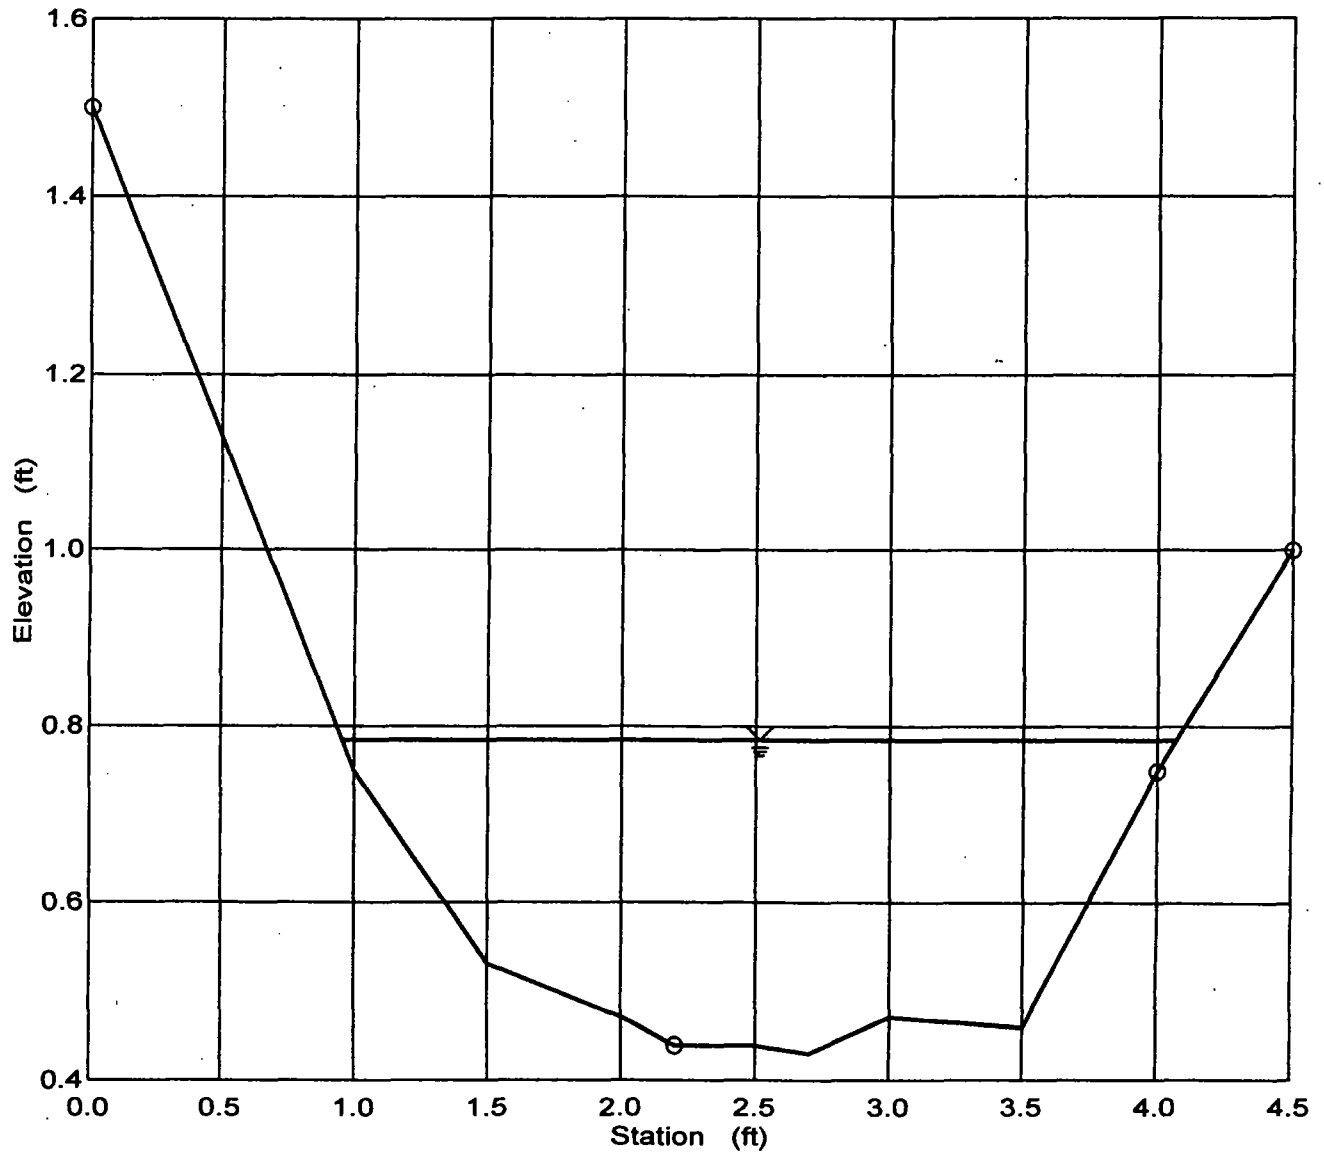
Section Data	
Wtd. Mannings Coefficient	0.036
Channel Slope	0.000491 ft/ft
Water Surface Elevation	0.79 ft
Discharge	0.29 cfs
